**Flood Control Project Maintenance
Levee Inspections**
LMA District Cover Sheet
Spring 2011 Levee Inspection Results

Sacramento Maintenance Yard Cache Creek

Levee Inspection Report By Mile - Spring 2011

Waterway	Bank	Unit Miles	Inspection Start/End	Inspector
Unit No. 01 North Levee	Left	11.81	04/13/2011 04/13/2011	John Williamson

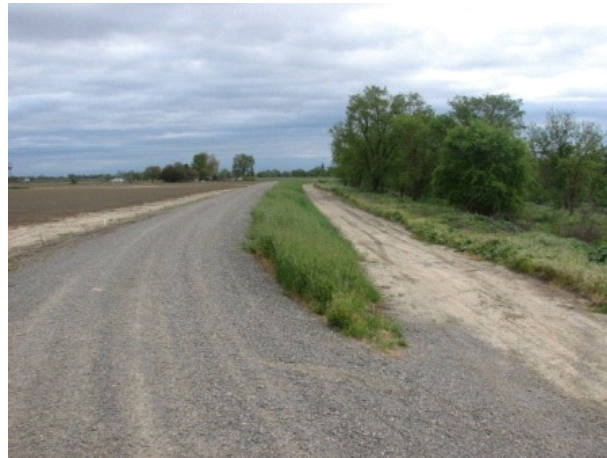
johngw_s_20110413_436.jpg

Levee Mile Report Line	1
Start Levee Mile	0.25
End Levee Mile	11.77
Location	Water Side
Category	Earthen Levee
Item	Vegetation

The vegetation complies with standards and needs to be mowed or burned.

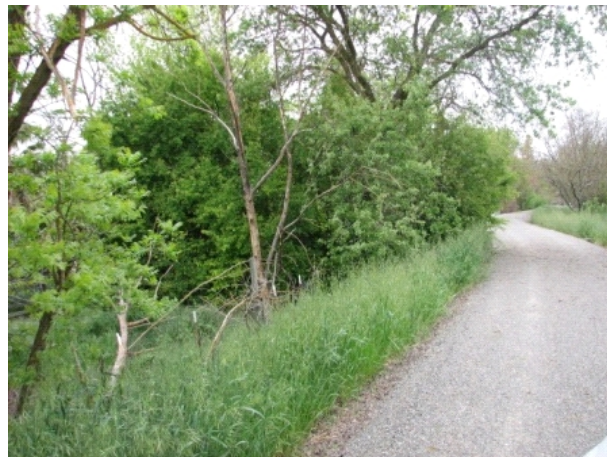
johngw_s_20110413_439.jpg

Levee Mile Report Line	2
Start Levee Mile	1.86
End Levee Mile	1.96
Location	Land Side
Category	Earthen Levee
Item	Encroachments

The landscape vegetation needs to be trimmed for visibility of the levee slope.

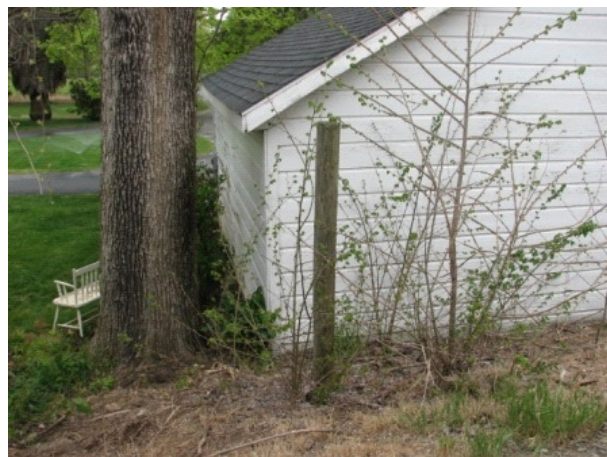
johngw_s_20110413_438.jpg

Levee Mile Report Line	3
Start Levee Mile	1.91
End Levee Mile	1.91
Location	Land Side
Category	Earthen Levee
Item	Encroachments

The building backs up to the landside levee toe of the levee.

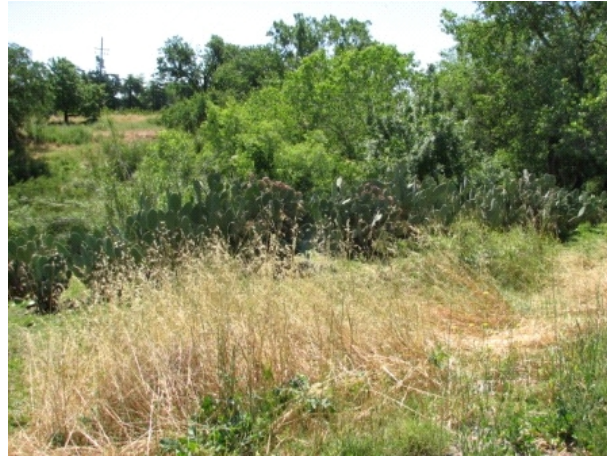
Levee Mile Report Line	5
Start Levee Mile	1.96
End Levee Mile	1.99
Location	Water Side
Category	Earthen Levee
Item	Encroachments
cactus garden	
johngw_s_20110228_305.jpg

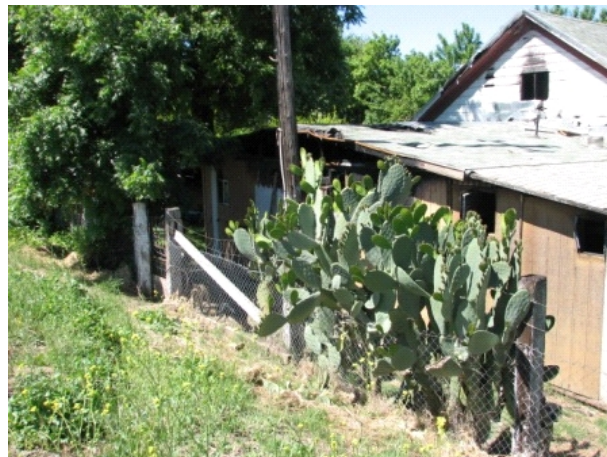
Levee Mile Report Line	7
Start Levee Mile	1.98
End Levee Mile	1.98
Location	Land Side
Category	Earthen Levee
Item	Encroachments
building and catus landside, town of Yolo	
johngw_s_20110228_306.jpg

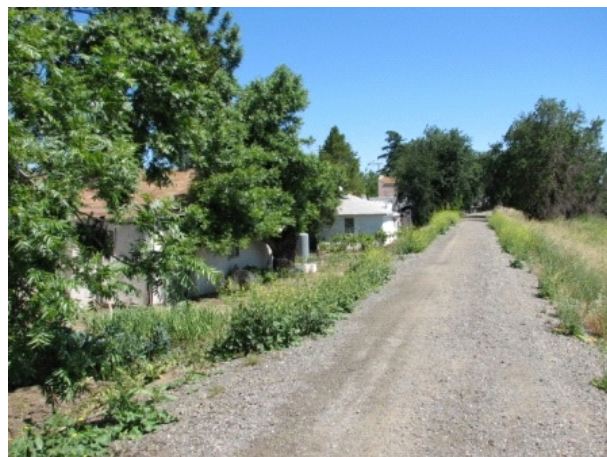
Levee Mile Report Line	8
Start Levee Mile	2.01
End Levee Mile	2.01
Location	Land Side
Category	Earthen Levee
Item	Encroachments
general photo of homes in the town of Yolo	
johngw_s_20110228_307.jpg

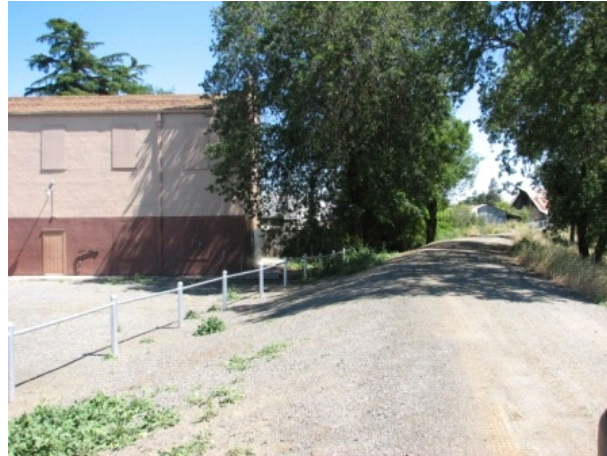
johngw_s_20110228_308.jpg

Levee Mile Report Line	11
Start Levee Mile	2.05
End Levee Mile	2.05
Location	Land Side
Category	Earthen Levee
Item	Encroachments

building close to toe

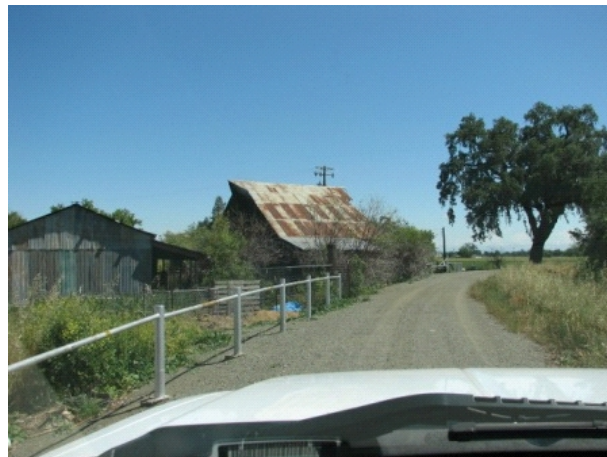
johngw_s_20110228_309.jpg

Levee Mile Report Line	17
Start Levee Mile	2.15
End Levee Mile	2.15
Location	Land Side
Category	Earthen Levee
Item	Encroachments

horse barn and corral

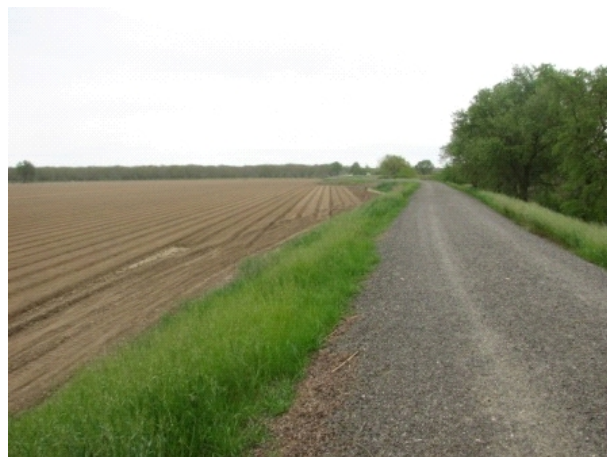
johngw_s_20110413_437.jpg

Levee Mile Report Line	18
Start Levee Mile	2.19
End Levee Mile	11.77
Location	Land Side
Category	Earthen Levee
Item	Vegetation

The vegetation complies with standards and needs to be mowed or burned.

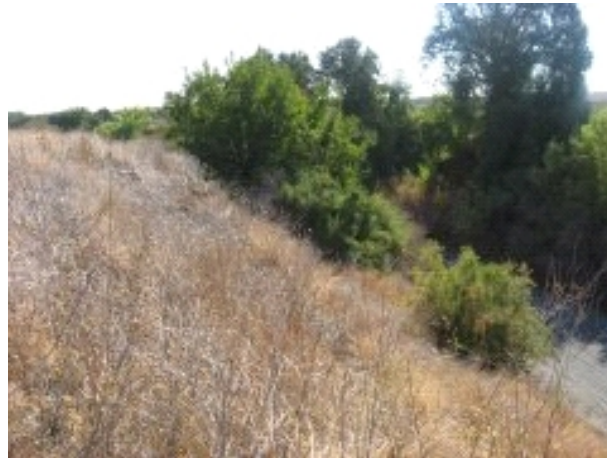
Levee Mile Report Line	19
Start Levee Mile	2.54
End Levee Mile	2.58
Location	Water Side
Category	Supplemental
Item	USACE Erosion Survey
2009: 15 ft berm, 1.5:1 slope, tree hazards, holes, and slumping, sands and silts, 4 ft/s [2009 SiteID:CHC_2-4_L]	
johngw_s_20110228_317.JPG

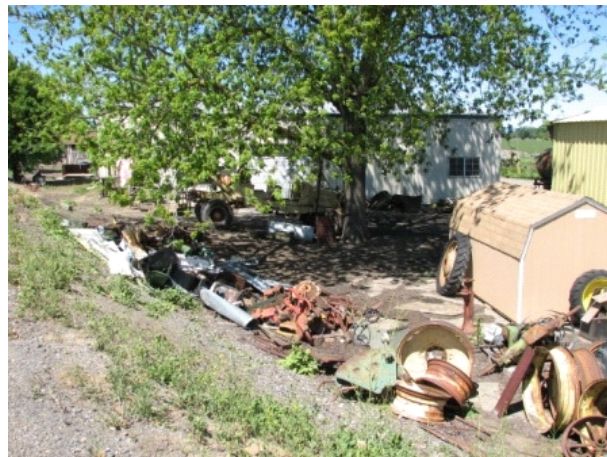
Levee Mile Report Line	20
Start Levee Mile	2.60
End Levee Mile	2.60
Location	Land Side
Category	Earthen Levee
Item	Encroachments
building and parts of tractors	
johngw_s_20110228_310.jpg

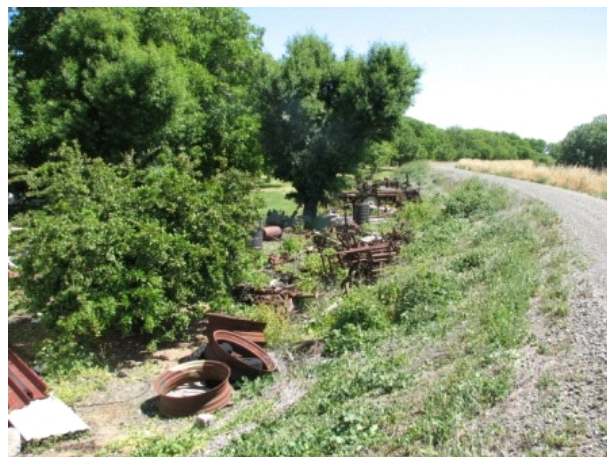
Levee Mile Report Line	22
Start Levee Mile	2.65
End Levee Mile	2.70
Location	Land Side
Category	Earthen Levee
Item	Encroachments
equipment and parts	
johngw_s_20110228_311.jpg

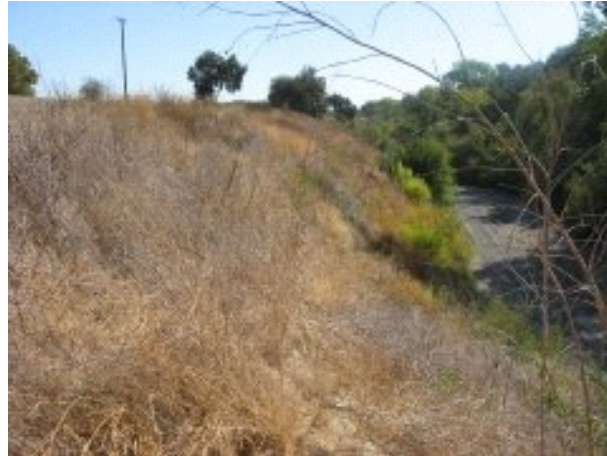
Levee Mile Report Line	25
Start Levee Mile	2.79
End Levee Mile	2.83
Location	Water Side
Category	Supplemental
Item	USACE Erosion Survey
2009: 15 ft berm, 1:1 slope, slumping, sands and silts, 5.89 ft/s [2009 SiteID:CHC_2-8_L]	
johngw_s_20110228_318.JPG

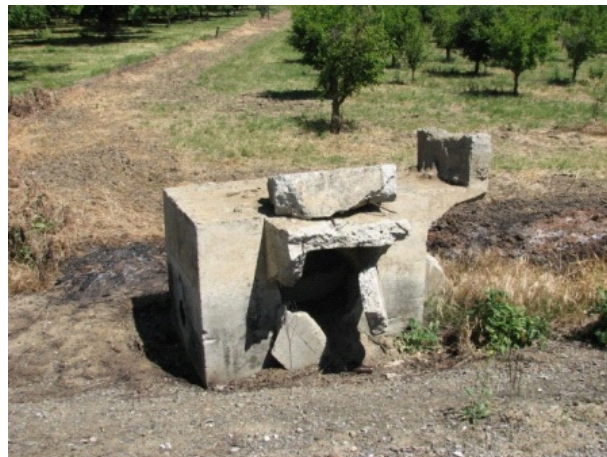
Levee Mile Report Line	26
Start Levee Mile	2.86
End Levee Mile	2.86
Location	Land Side
Category	Earthen Levee
Item	Encroachments
concrete debris	
johngw_s_20110228_313.jpg

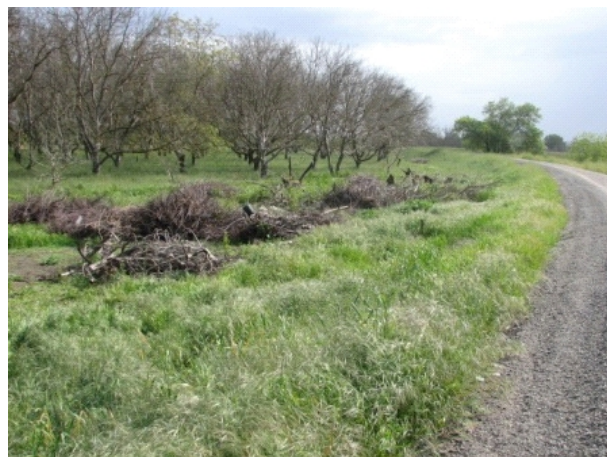
Levee Mile Report Line	27
Start Levee Mile	3.06
End Levee Mile	3.06
Location	Land Side
Category	Earthen Levee
Item	Encroachments
The prunings from this season have been re-piled at the toe of the levee.	
johngw_s_20110413_440.jpg

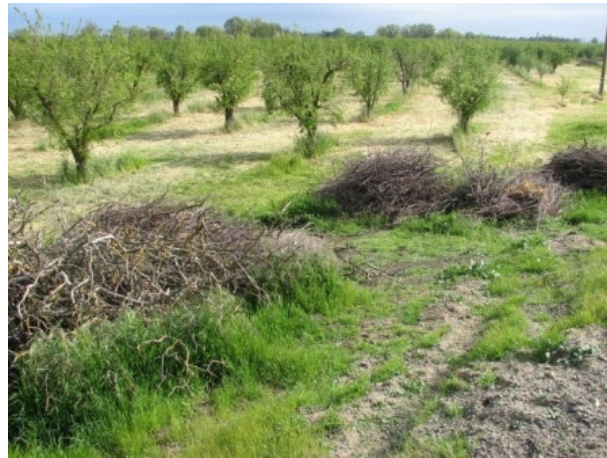
johngw_s_20110413_441.jpg

Levee Mile Report Line	28
Start Levee Mile	3.22
End Levee Mile	3.22
Location	Land Side
Category	Earthen Levee
Item	Encroachments

This seasons prunings have been piled up against the toe of the landside levee.

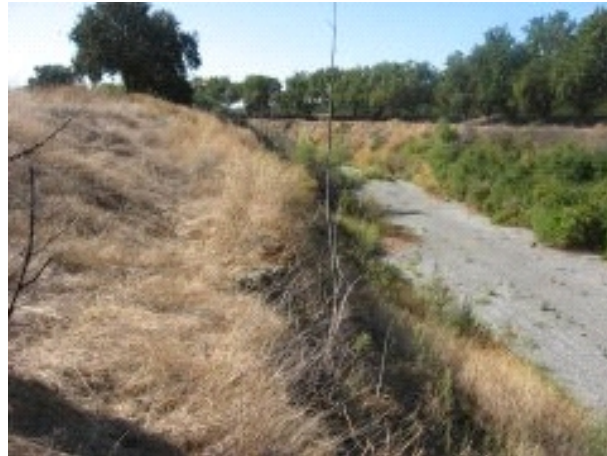
johngw_s_20110228_319.JPG

Levee Mile Report Line	29
Start Levee Mile	3.46
End Levee Mile	3.52
Location	Water Side
Category	Supplemental
Item	USACE Erosion Survey

2009: 15 ft berm, 1:1 slope, holes and slumping, sands and silts, 6.5 ft/s [2009 SiteID:CHC_3-4_L]

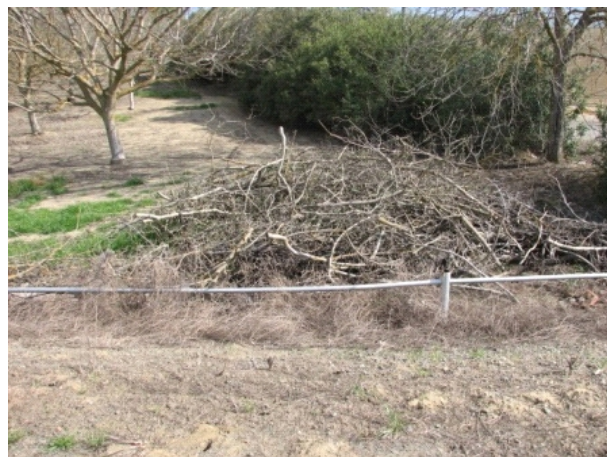
johngw_s_20110413_442.jpg

Levee Mile Report Line	31
Start Levee Mile	3.86
End Levee Mile	3.86
Location	Land Side
Category	Earthen Levee
Item	Encroachments

Walnut prunings are piled up against the landside levee toe.

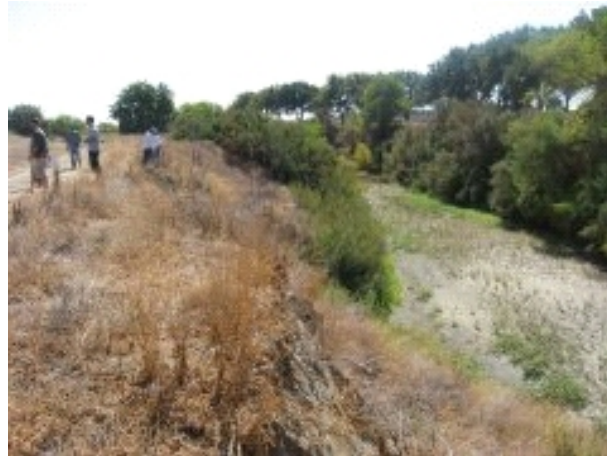
Levee Mile Report Line	32
Start Levee Mile	3.86
End Levee Mile	3.94
Location	Water Side
Category	Supplemental
Item	USACE Erosion Survey
2009: 10 ft berm, 1:1 slope, tree hazards and holes, sands and silts, 6 ft/s [2009 SiteID:CHC_3-9_L]	
johngw_s_20110228_320.JPG

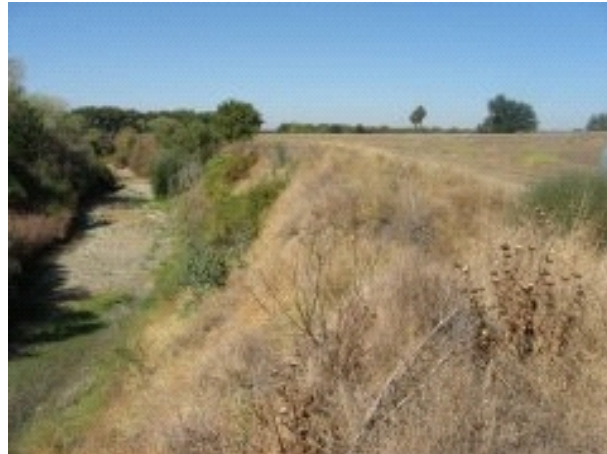
33	4.13	4.27	Supplemental	USACE Erosion Survey	WS	M	Inspector Comments: 2009: 3 ft berm, 1.5:1 slope, tree hazards and holes, sands and silts, 4 ft/s [2009 SiteID:CHC_4-2_L]	38.727358 ° -121.776928 °	38.726933 ° -121.774417 °	41 Y
34	4.27	4.42	Earthen Levee	Encroachments	LS	PO	Landscaping	38.727047 ° -121.774413 °	38.726113 ° -121.771929 °	27 Y
35	4.33	4.33	Earthen Levee	Encroachments	LS	C	Prunings	38.726828 ° -121.773278 °	38.726828 ° -121.773278 °	44 Y

Levee Mile Report Line	33
Start Levee Mile	4.13
End Levee Mile	4.27
Location	Water Side
Category	Supplemental
Item	USACE Erosion Survey
2009: 3 ft berm, 1.5:1 slope, tree hazards and holes, sands and silts, 4 ft/s [2009 SiteID:CHC_4-2_L]	
johngw_s_20110228_323.JPG

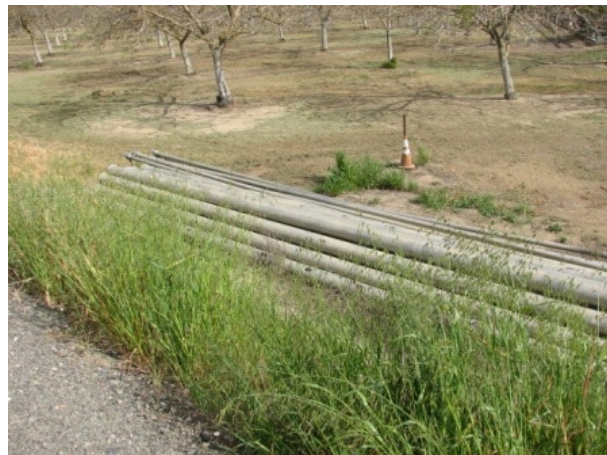
Levee Mile Report Line	36
Start Levee Mile	4.76
End Levee Mile	4.76
Location	Land Side
Category	Earthen Levee
Item	Encroachments
Aluminum irrigation pipe is placed along the landside levee toe.	
johngw_s_20110413_443.jpg

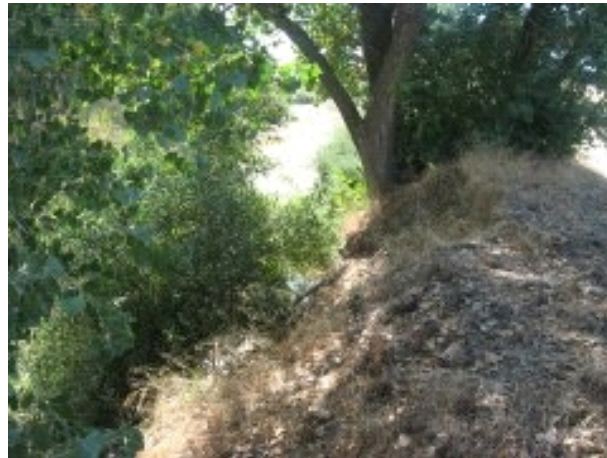
Levee Mile Report Line	37
Start Levee Mile	5.33
End Levee Mile	5.37
Location	Water Side
Category	Supplemental
Item	USACE Erosion Survey
2009: 15 ft berm, vertical slope, tree hazards, holes, and slumping, sands and silts, 9.39 ft/s [2009 SiteID:CHC_5-4_L]	
johnngw_s_20110228_324.JPG

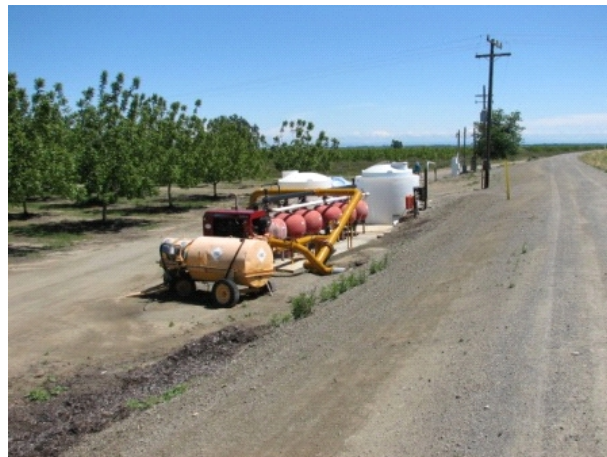
Levee Mile Report Line	39
Start Levee Mile	6.31
End Levee Mile	6.31
Location	Land Side
Category	Earthen Levee
Item	Encroachments
pipe through levee filter and fertilizer tanks	
johnngw_s_20110228_316.jpg

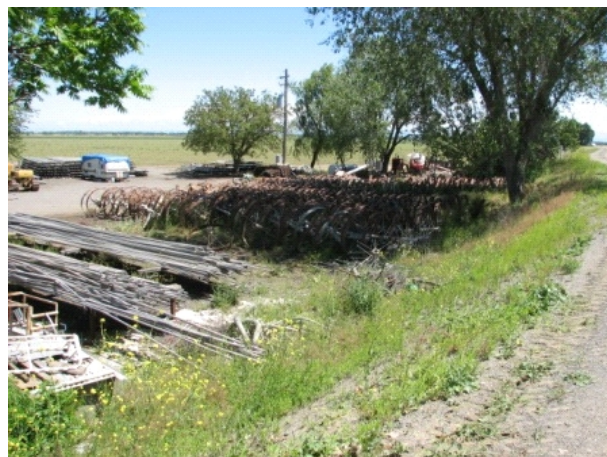
Levee Mile Report Line	43
Start Levee Mile	7.33
End Levee Mile	7.38
Location	Land Side
Category	Earthen Levee
Item	Encroachments
irrigation equipment	
johnngw_s_20110228_322.jpg

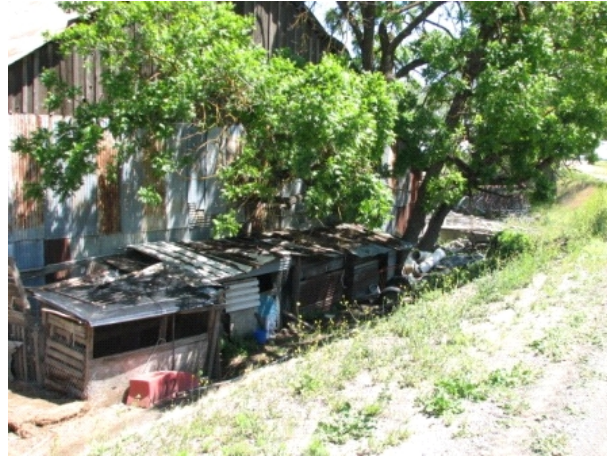
johngw_s_20110228_321.jpg

Levee Mile Report Line	44
Start Levee Mile	7.33
End Levee Mile	7.33
Location	Land Side
Category	Earthen Levee
Item	Encroachments

barn and livestock pens

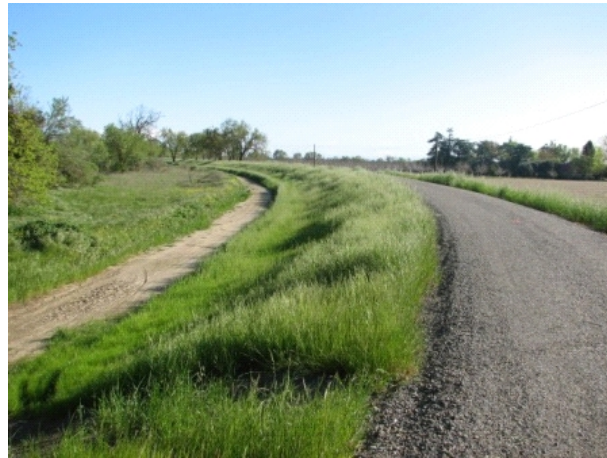
johngw_s_20110411_422.jpg

Levee Mile Report Line	1
Start Levee Mile	0.02
End Levee Mile	11.39
Location	Water Side
Category	Earthen Levee
Item	Vegetation

The view is of the waterside levee slope. The vegetation complies with standards.

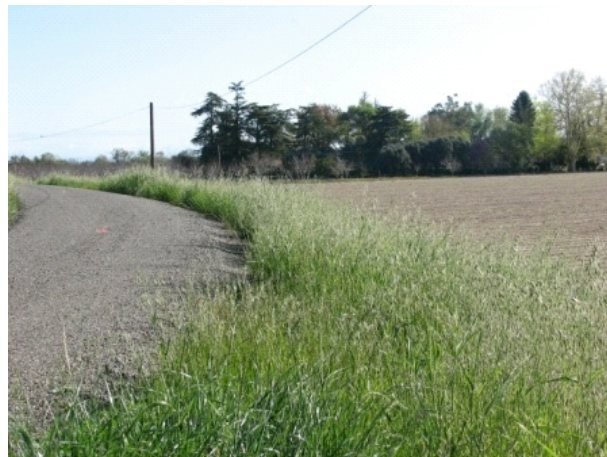
johngw_s_20110411_423.jpg

Levee Mile Report Line	2
Start Levee Mile	0.02
End Levee Mile	11.39
Location	Land Side
Category	Earthen Levee
Item	Vegetation

The view is of the landside levee slope. The vegetation complies with standards.

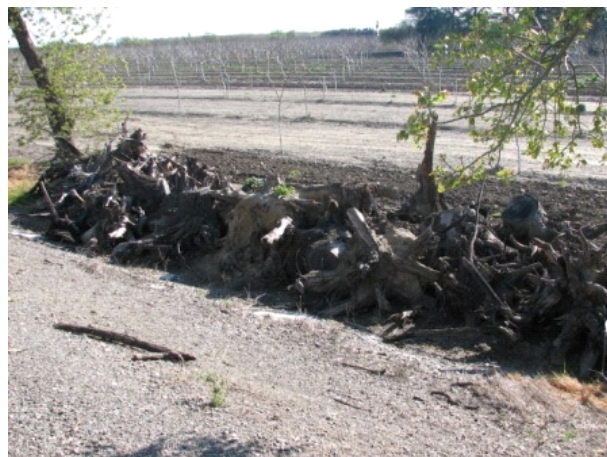
johngw_s_20110411_424.jpg

Levee Mile Report Line	3
Start Levee Mile	0.18
End Levee Mile	0.18
Location	Land Side
Category	Earthen Levee
Item	Encroachments

The stumps have not been removed or burned along the toe of the levee.

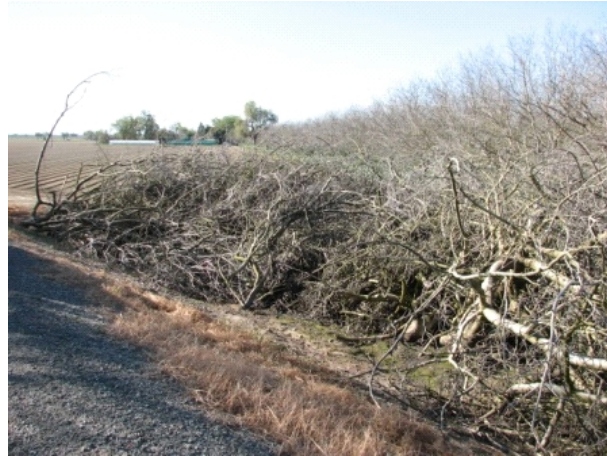
johngw_s_20110411_426.jpg

Levee Mile Report Line	6
Start Levee Mile	1.63
End Levee Mile	1.63
Location	Land Side
Category	Earthen Levee
Item	Encroachments

Trimmings from the walnut orchard piled up along the toe of the levee.

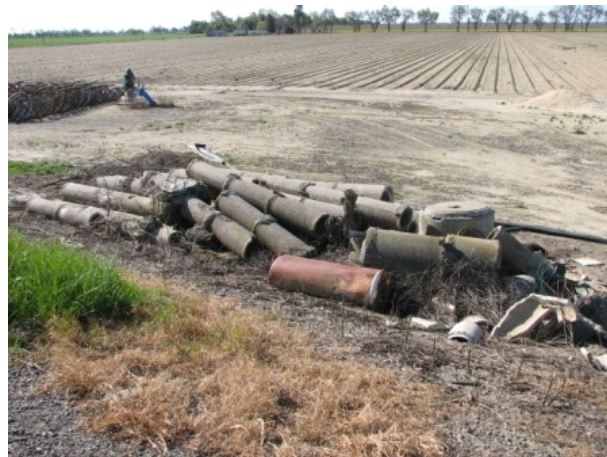
johngw_s_20110411_427.jpg

Levee Mile Report Line	7
Start Levee Mile	2.36
End Levee Mile	2.36
Location	Land Side
Category	Earthen Levee
Item	Encroachments

Old concrete pipe debris is stacked up along the toe of the levee.

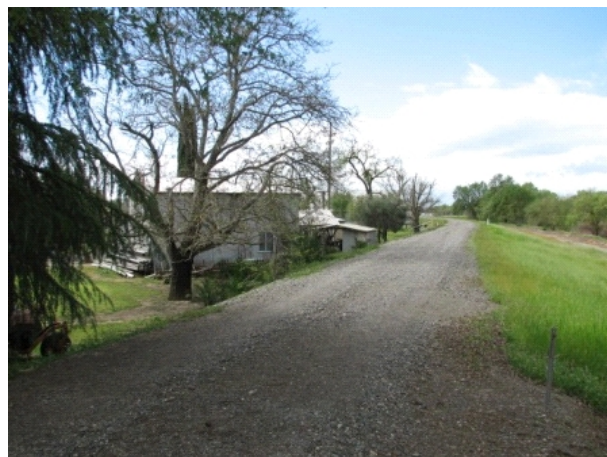
johngw_s_20110228_327.jpg

Levee Mile Report Line	9
Start Levee Mile	4.00
End Levee Mile	4.04
Location	Land Side
Category	Earthen Levee
Item	Encroachments

out building at toe

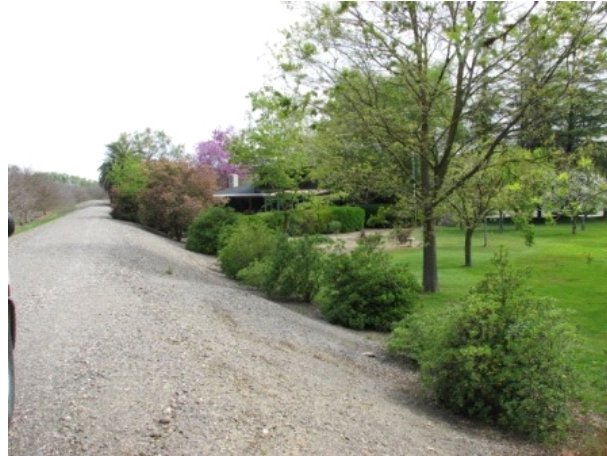
johngw_s_20110228_328.jpg

Landscaping

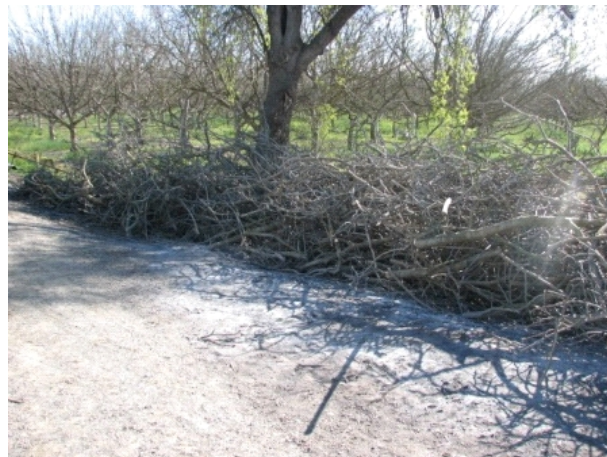
johngw_s_20110411_428.jpg

Levee Mile Report Line	11
Start Levee Mile	4.14
End Levee Mile	4.14
Location	Land Side
Category	Earthen Levee
Item	Encroachments

Trimming from the walnut orchard is stacked up on the levee slope.

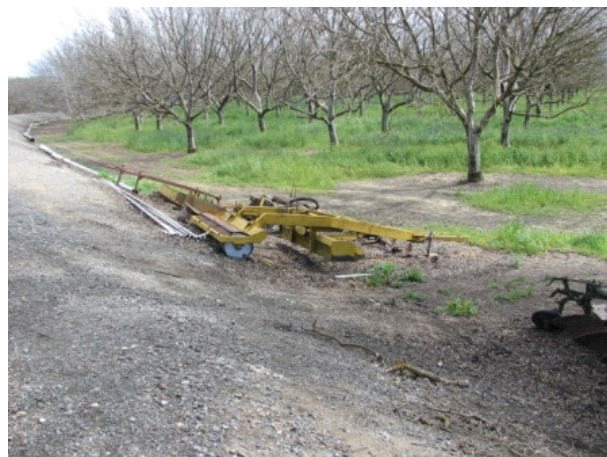
johngw_s_20110228_330.jpg

Levee Mile Report Line	12
Start Levee Mile	4.15
End Levee Mile	4.15
Location	Land Side
Category	Earthen Levee
Item	Encroachments

Pipe run on toe along orchard

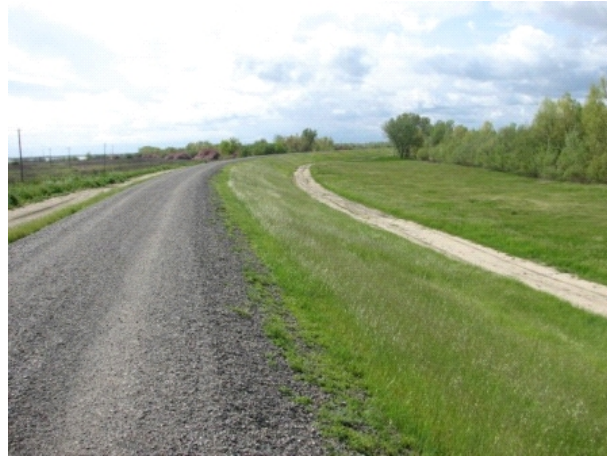
johngw_s_20110413_434.jpg

The photo is of the waterside levee slope. The vegetation complies with standards.

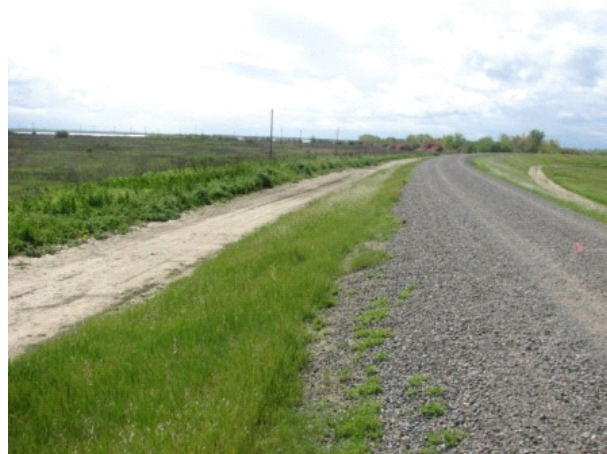
johngw_s_20110413_435.jpg

Levee Mile Report Line	2
Start Levee Mile	0.05
End Levee Mile	2.27
Location	Land Side
Category	Earthen Levee
Item	Vegetation

The vegetation complies with standards and needs to be mowed or burned.
